Rimkus Consulting Group, Inc.
Eight Greenway Plaza, Suite 500
Houston, TX 77046
(800) 580-3228 Telephone
(713) 623-4357 Facsimile

Re: RCG File No: 11009971
LLV Number: 0209452
VMF Location: 1530 Greensmark Drive in Houston, Texas
Subject: Final Report

Rimkus Consulting Group, Inc. was retained to examine LLV 0209452, VIN 1GBCS10E4M2908832. The fire occurred on June 13, 2016 at around 12:30 P.M. the operator of the vehicle at the time of the fire, was unavailable for interview but reportedly stated the vehicle's engine died while delivering mail on his route and backfired during subsequent attempts to restart it. Soon thereafter, smoke was observed from beneath the hood as well as flames.

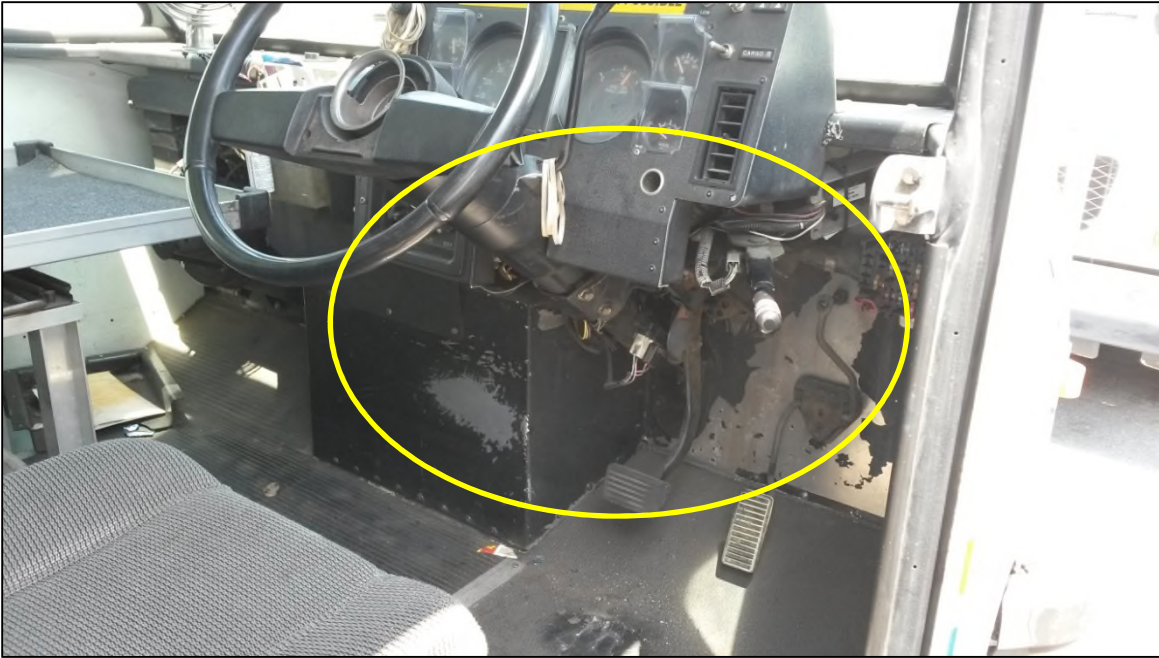
Photograph 5

Driver's Seat, steering column and dashboard area.

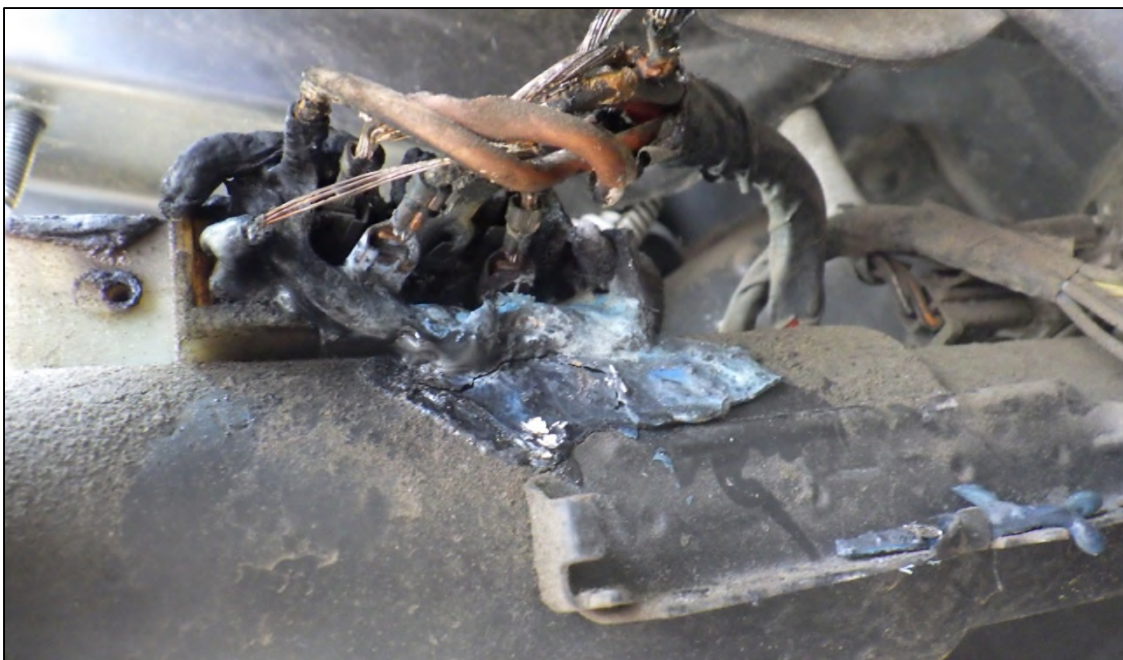
Photograph 8

A close up of the wiring connection terminals and the point of fire origin.

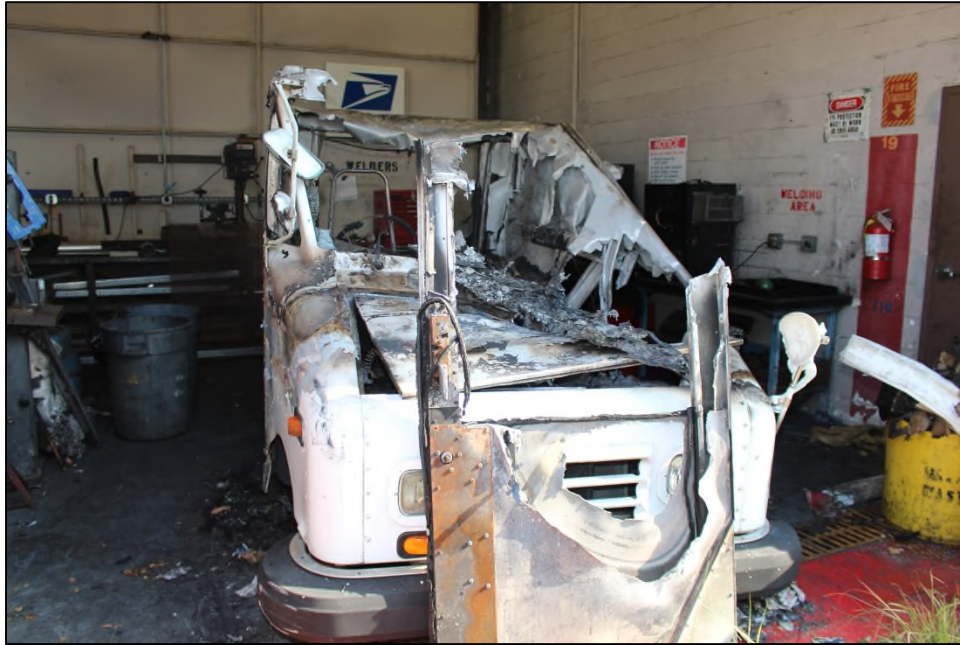
Photograph 1

View of the fire-damaged LLV as found in the VMF located in Miami, Florida.

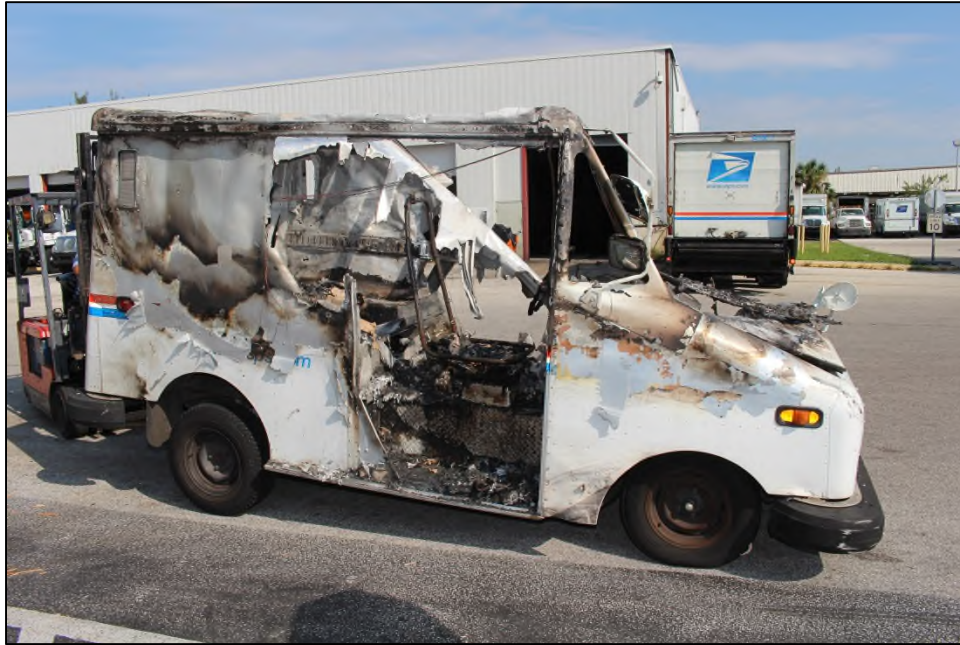
Photograph 3

View of the driver's side of fire damaged LLV 8206799.

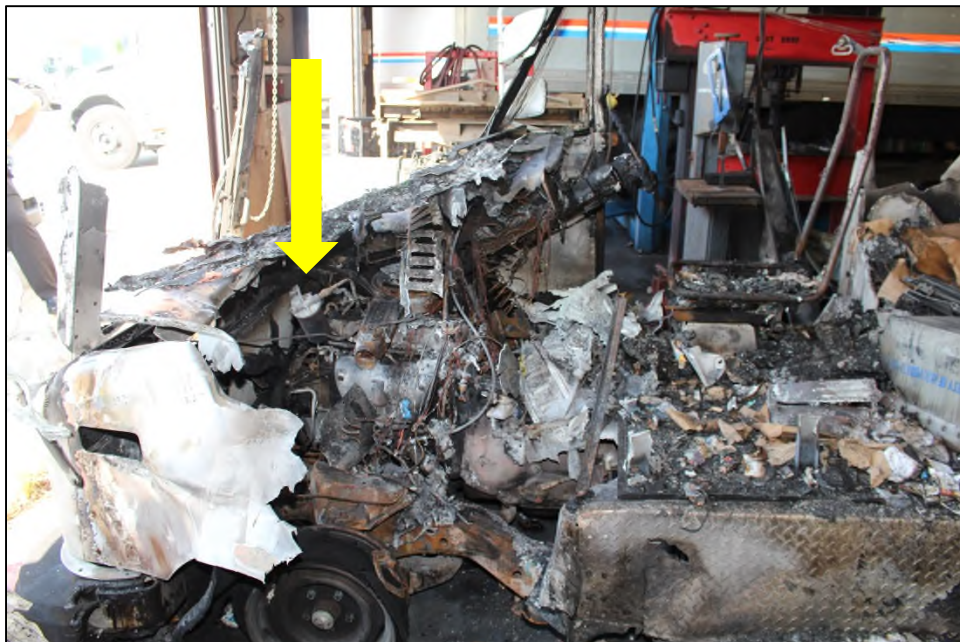
Photograph 4

View of left, front side of the fire-damaged vehicle. The severed fuel filter was found towards the front of the engine compartment near the radiator.

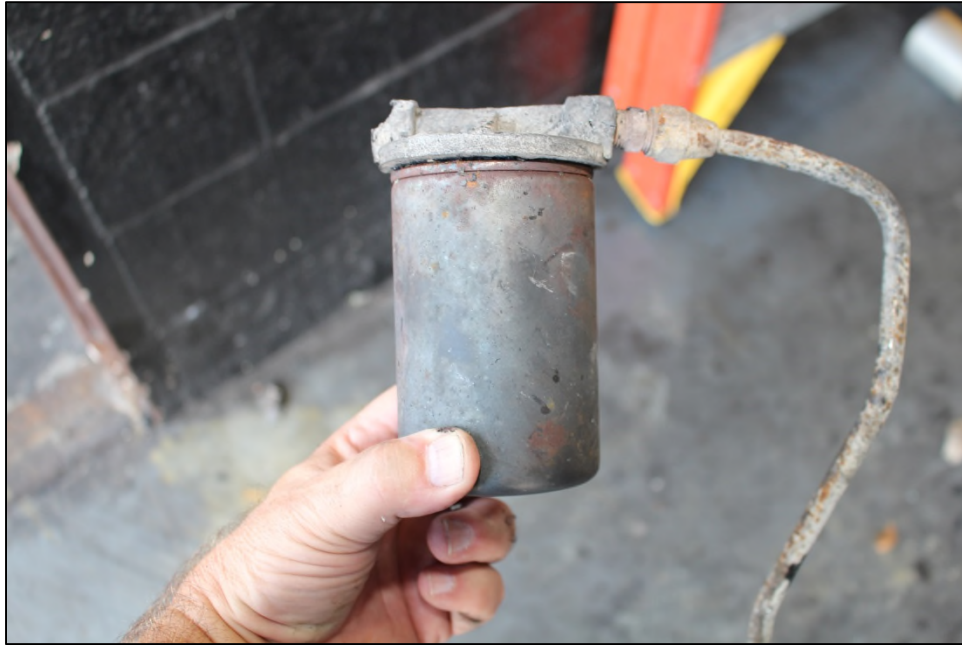
Photograph 5

View of the fuel filter.

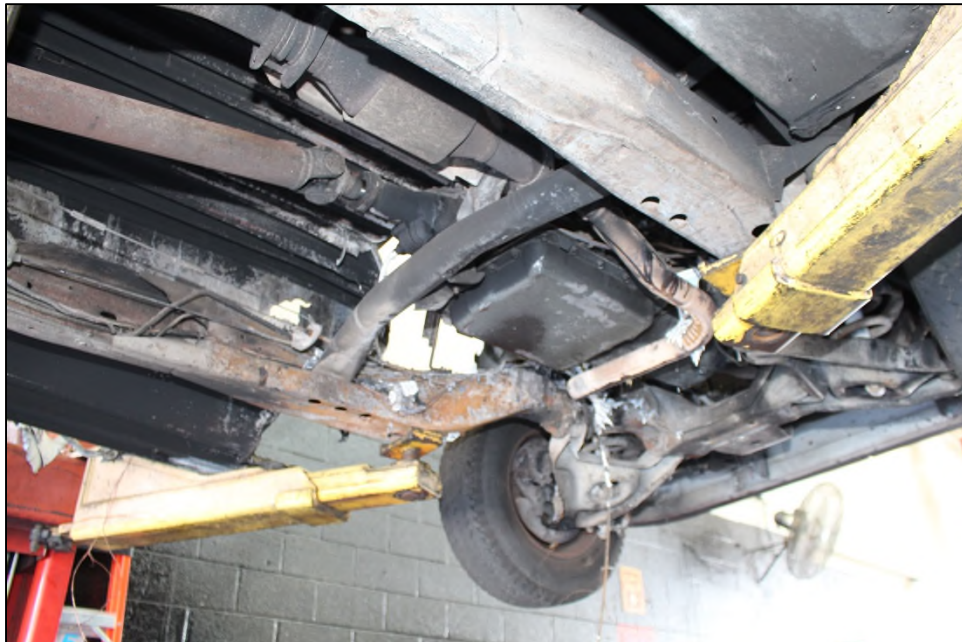
Photograph 6

View of the undercarriage looking towards the front left side of the vehicle where the fuel filter had been positioned.

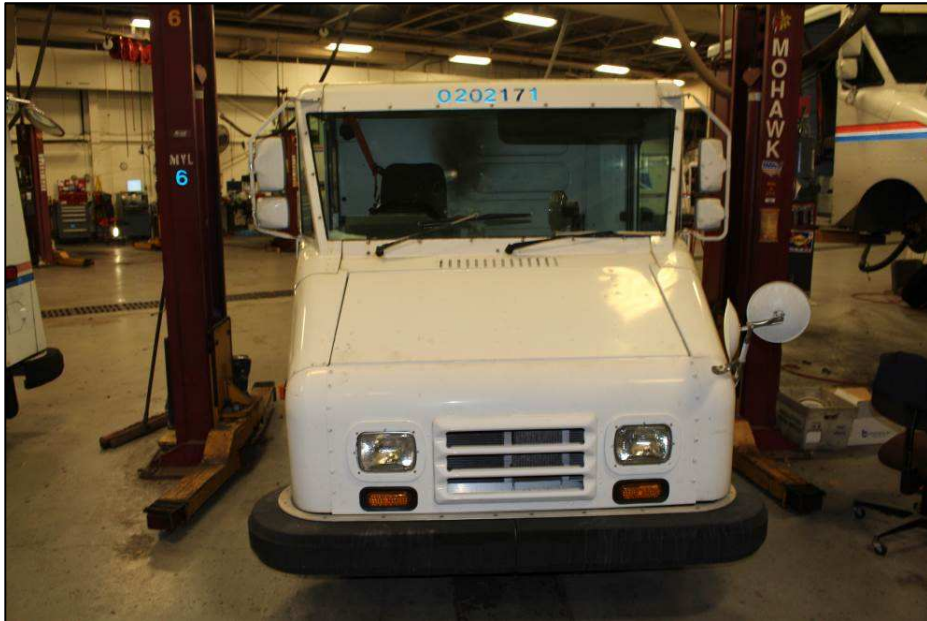
Photograph 1

Front of vehicle. Minor smoke stains in middle of window.

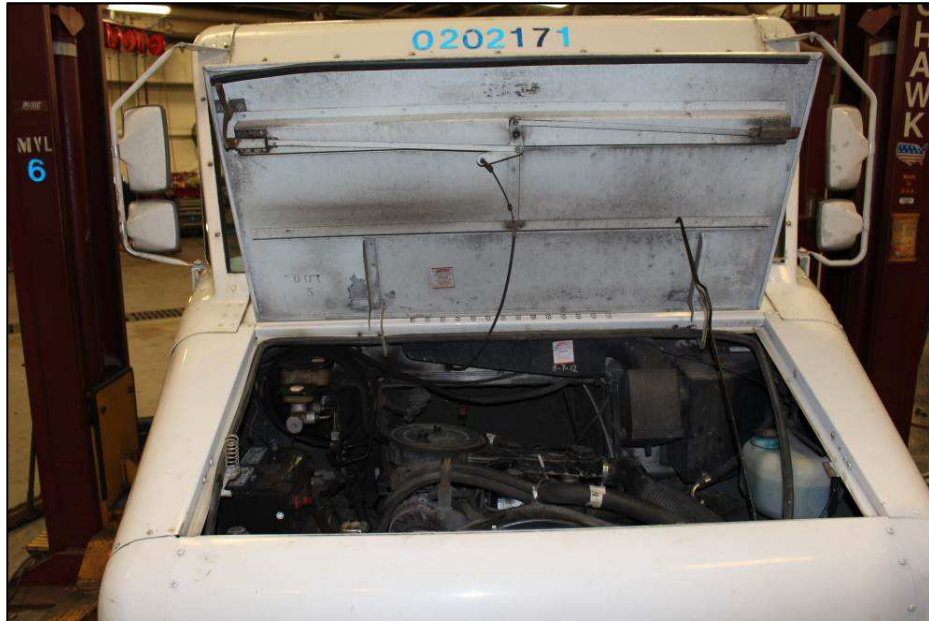
Photograph 3

The engine compartment was examined. No fire damage was noted. The fuel system was examined and found to be intact with no damage noted. The fuel filter was intact and located along rear of the engine near the fire wall. The fuel system was a GM model. The battery for the vehicle was located at the front right side of the engine compartment and had no fire damage. Based on the fire patterns, the engine compartment was not the area of origin.

Engine compartment. No fire damage.

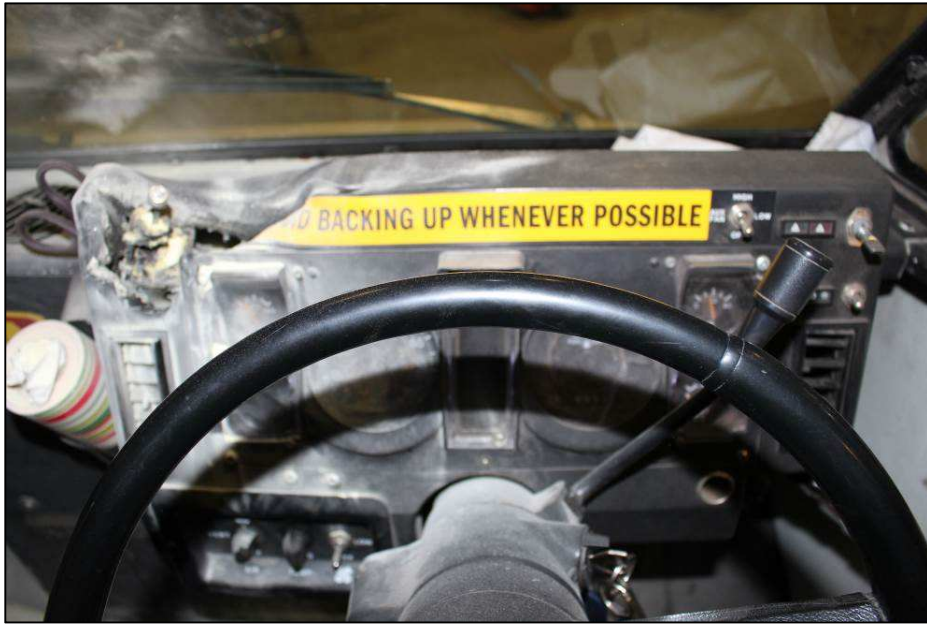
Photograph 5

Examination of the interior of the vehicle revealed the most severe fire damage had occurred to the middle top of the dashboard area. The plastic material in the left side of the dashboard had melted at the headlamp switch. The electrical wiring was examined and did not display any signs of adverse electrical activity. Examination of the headlamp switch components revealed the switch was melted and revealed signs of overheating. Examination of the electrical wiring that transverse behind the dashboard were examined and revealed no signs of obvious failure. Further inspection of the headlamp switch assembly revealed the high/low beam switch located under the steering wheel had minor burn marks on the electrical prongs in the wiring harness. The switch was also examined and revealed minor burning to the switch components where the wiring harness connected.

Dashboard area. Fire damage to left top side.

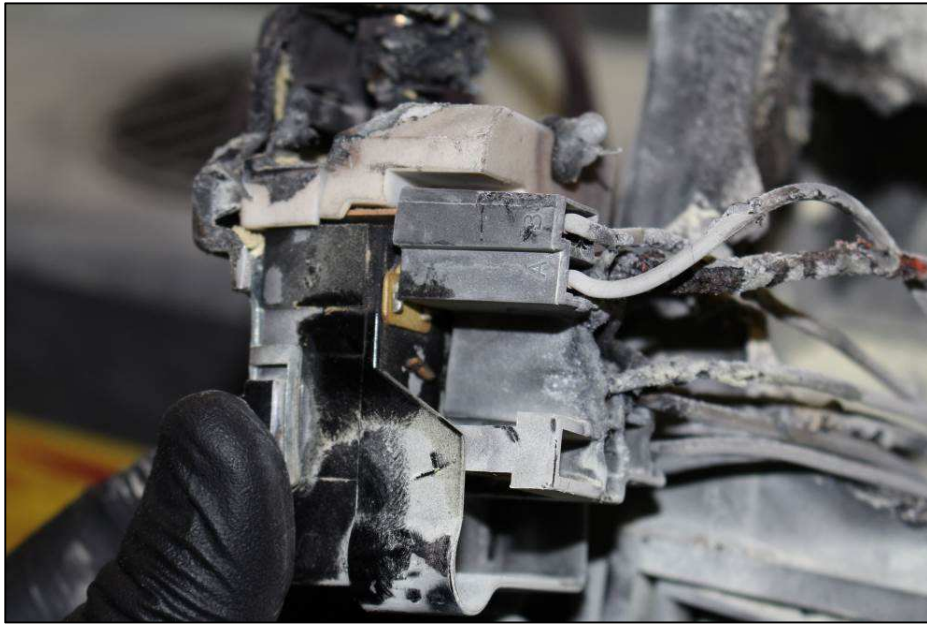
Photograph 7

Headlamp switch. Electrical conductors on back of switch.

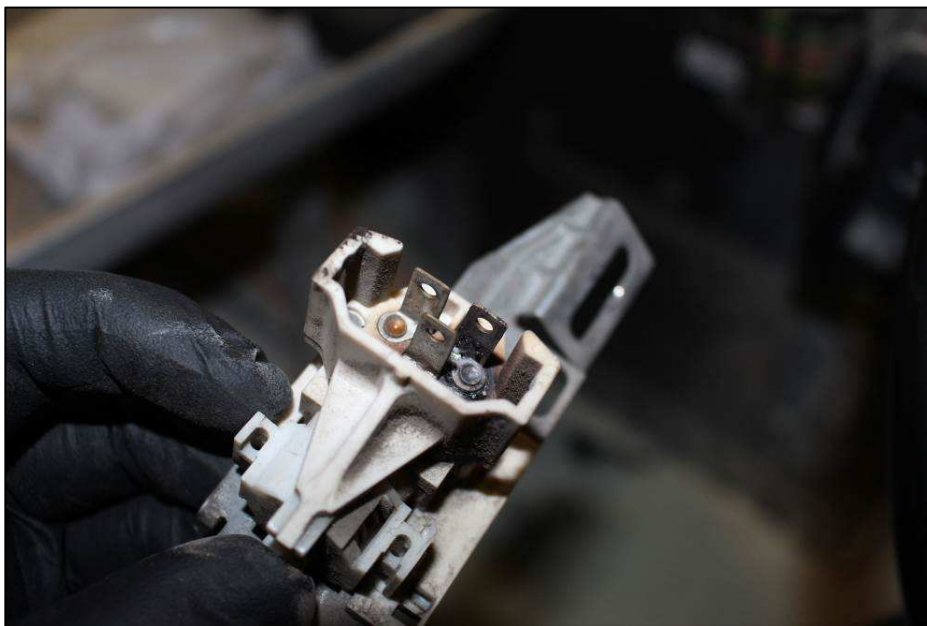
Photograph 8

3. Melting damage was also observed under the dashboard at the high beam connector from what appeared to be a loose connector.
4. The specific ignition sequence and cause of the fire was determined to be a direct result of heating at the rheostat switch from the dimmer on the headlamp switch. There also appeared to be issues with the wiring configuration to the connector.
5. The headlamp switch and high/low beam had been repaired by a third party vendor just prior to the fire.

High/low beam switch.

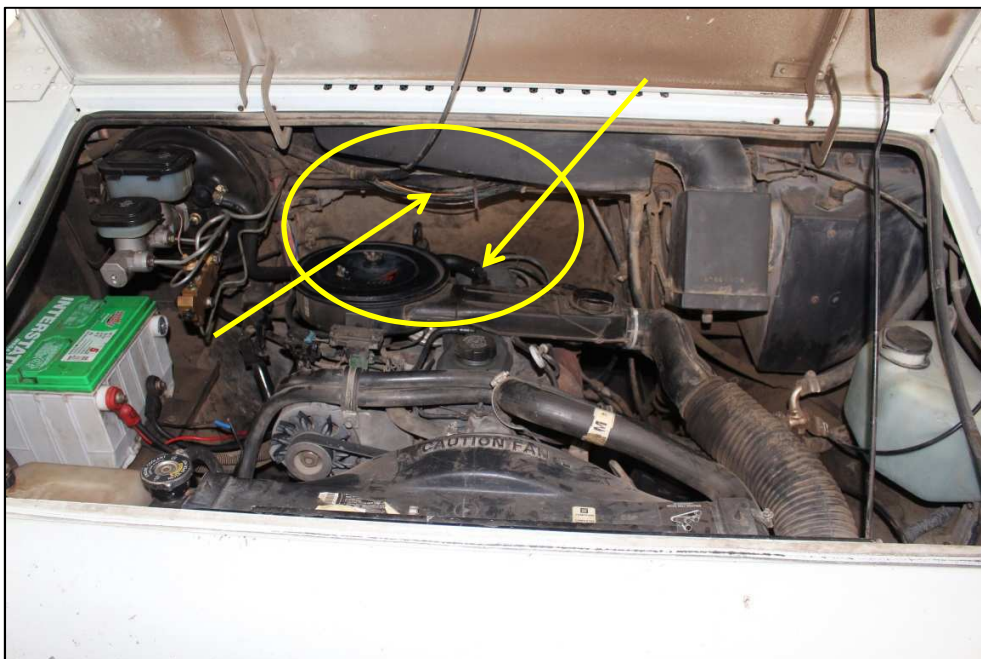
Photograph 2
Engine compartment. Yellow circle indicates fire damaged area. Yellow arrows indicate fire/heat areas.

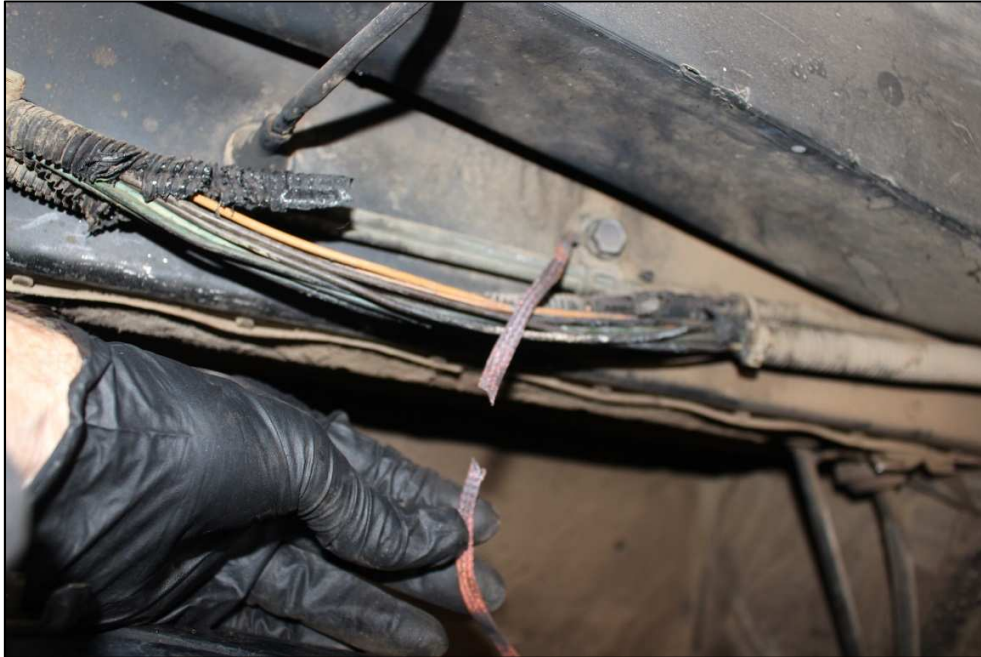
Photograph 3

Wiring harness ignited by heated ground strap at bulkhead above rear of engine.

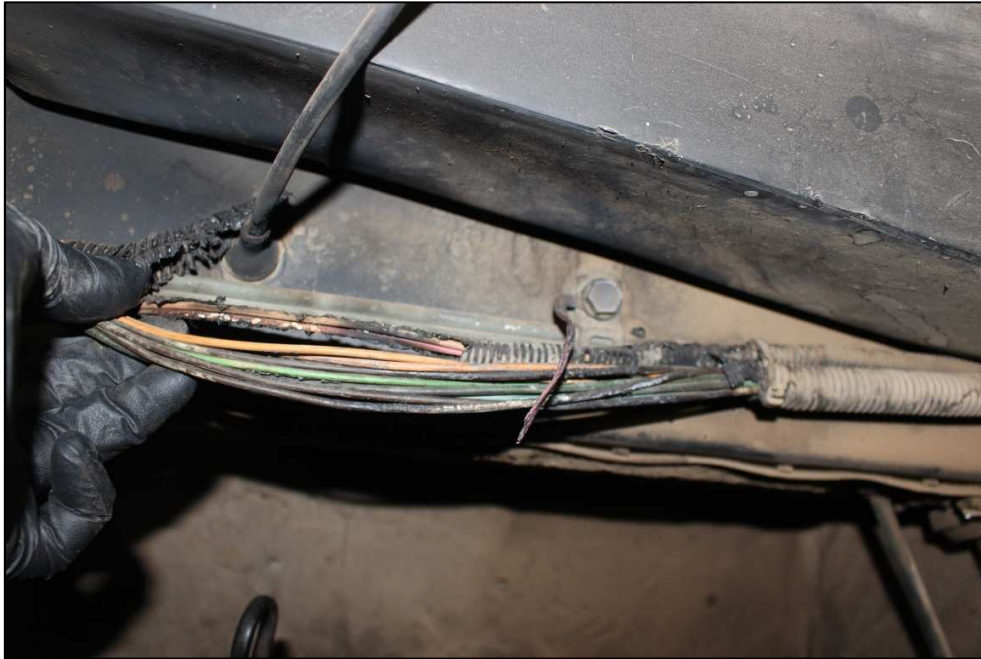
Photograph 5

Wiring harness at bulkhead relatively intact and indicated external heat exposure.

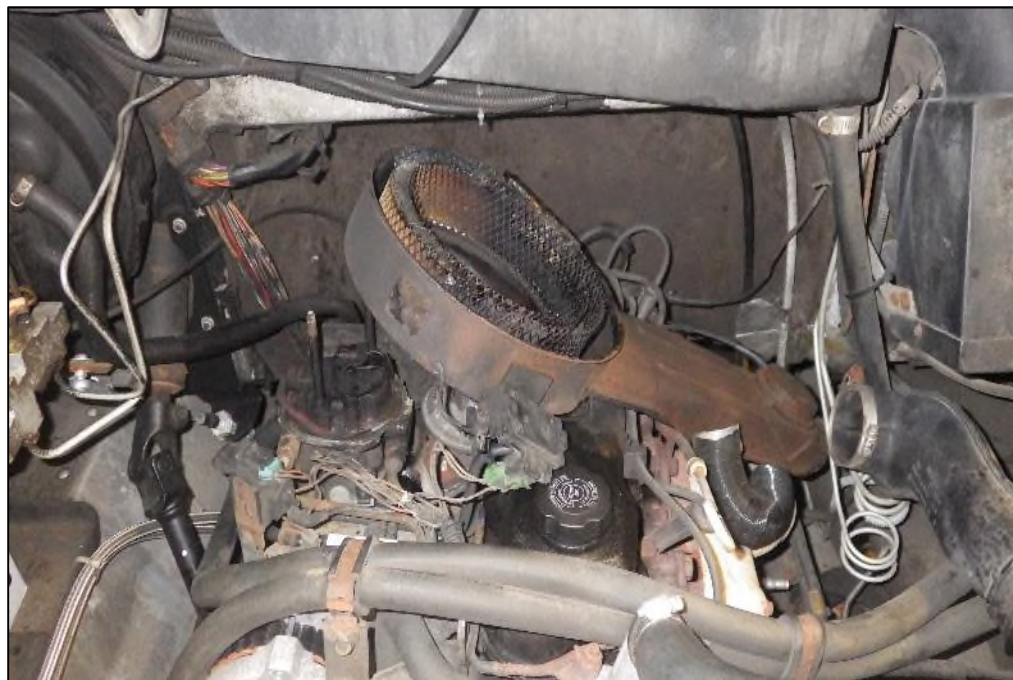
Photograph 2

Based on the observed pattern of fire damage and a systematic evaluation of the remaining physical evidence it was determined that the fire originated in the engine compartment. The specific area of the origin was the area between the throttle body injection unit and the air filter housing.

Overall view of engine compartment.

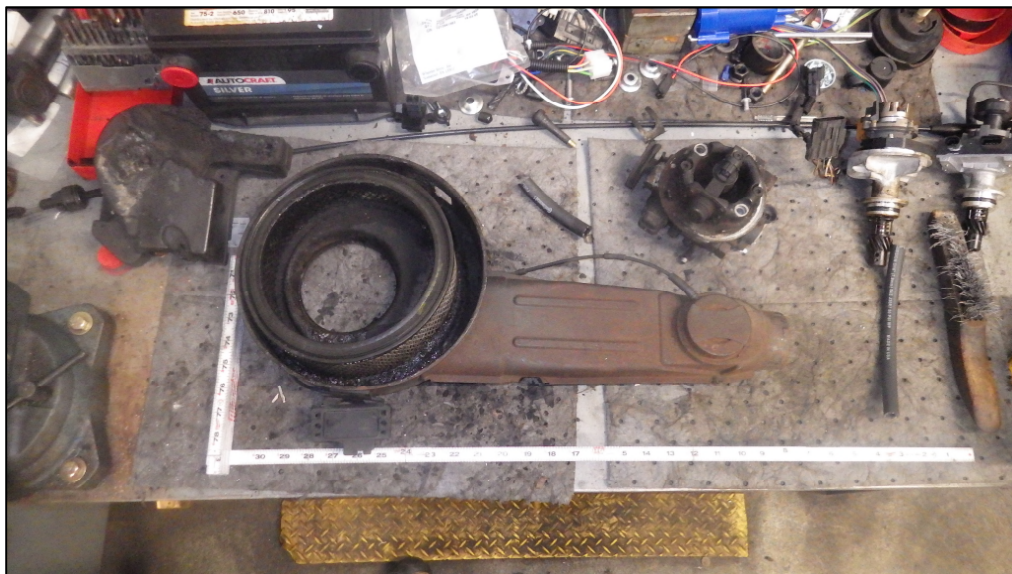
Photograph 4

View of the air cleaner and remains of the air filter.

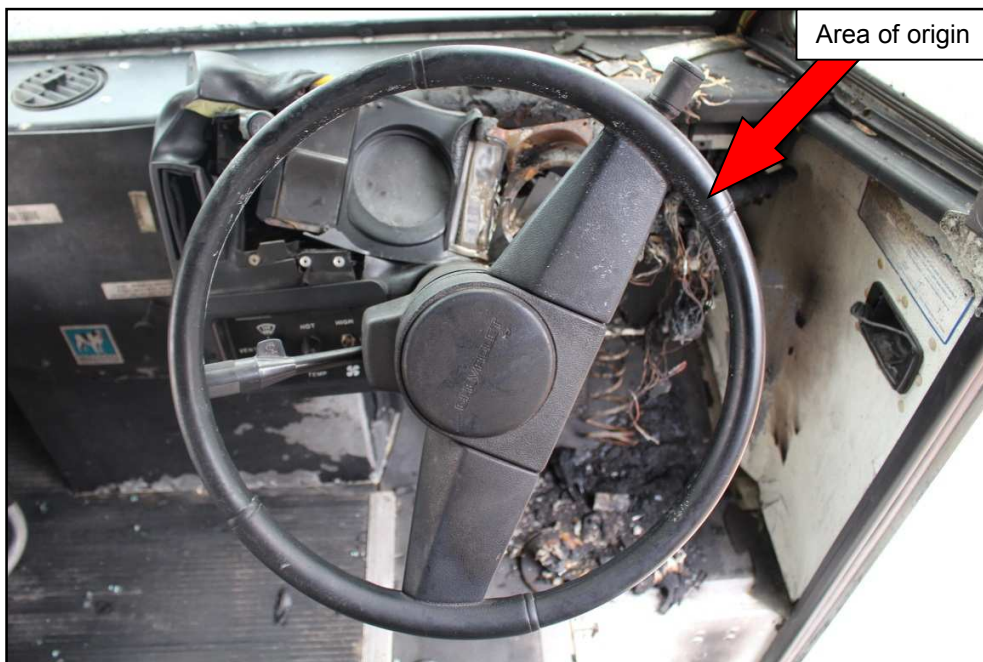
Photograph 2

The fire originated on the right side of the dash board in the area of the hazard switch.

Dash board and the area of the fire origin.

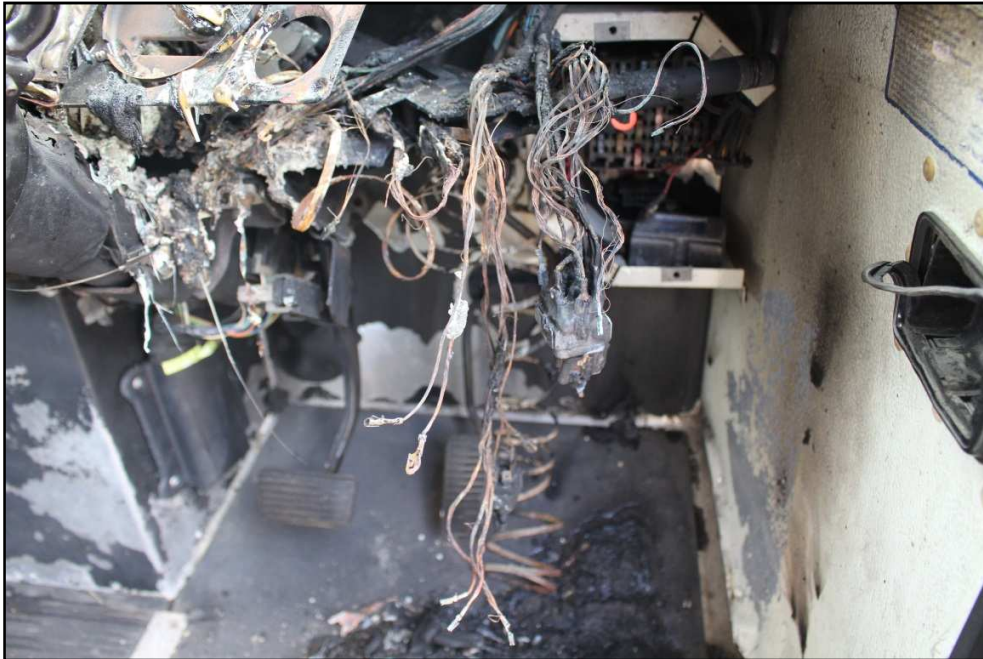
Photograph 3

Close up of the area of origin and components involved.

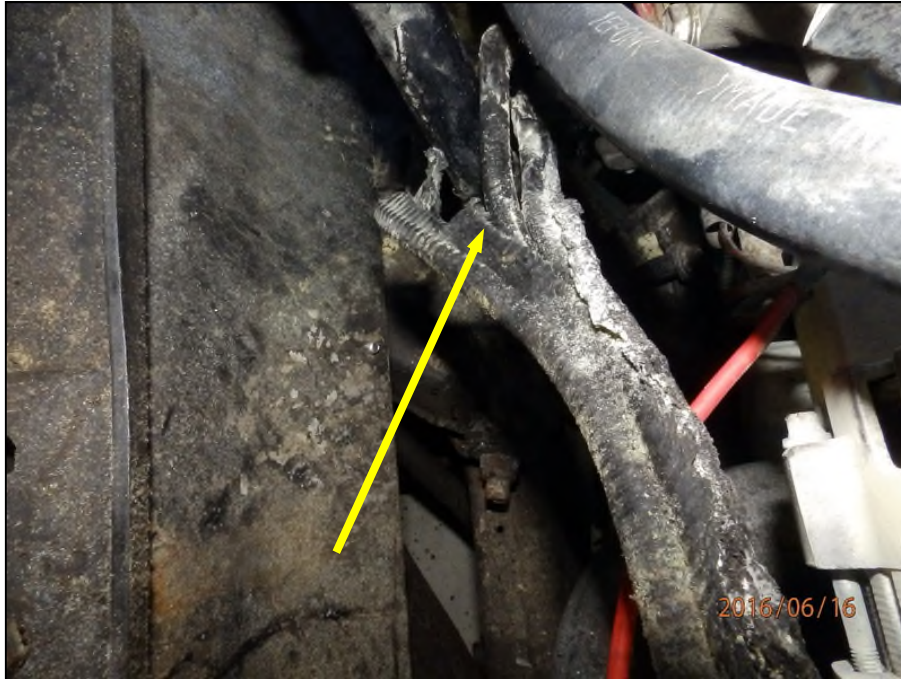
Photograph 1

A view of the fire damaged plastic loom.

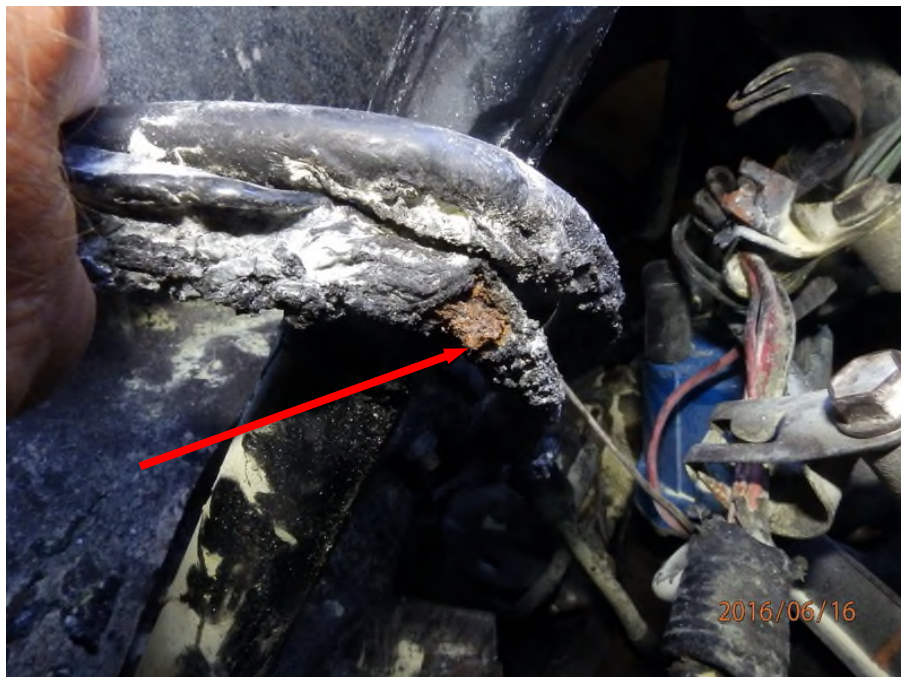
Photograph 2

A view of the electrical conductor from the battery to the starter.

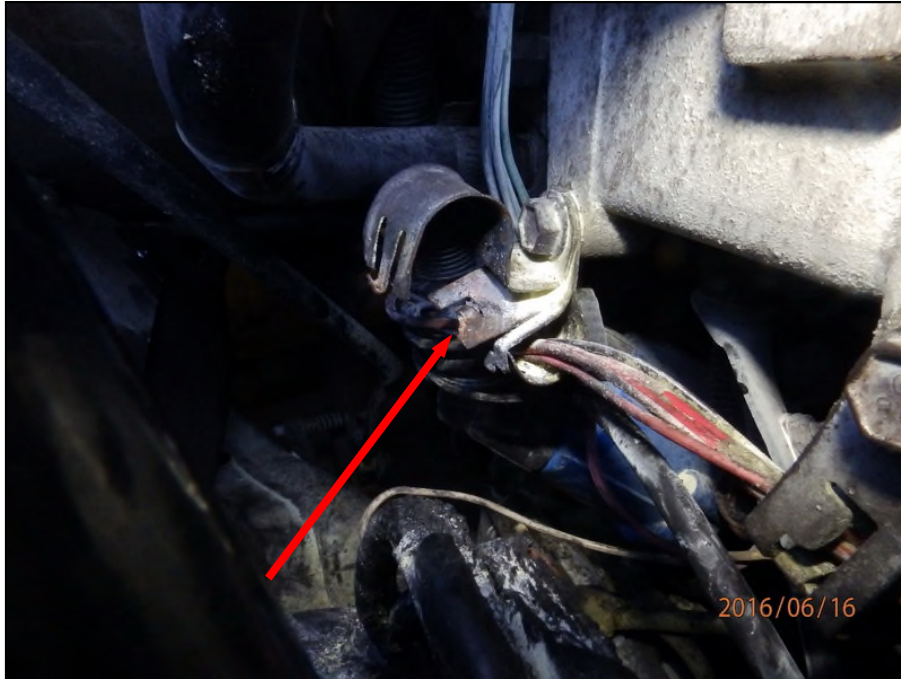
Photograph 3

A view of the steel bracket which chaffed the conductor.

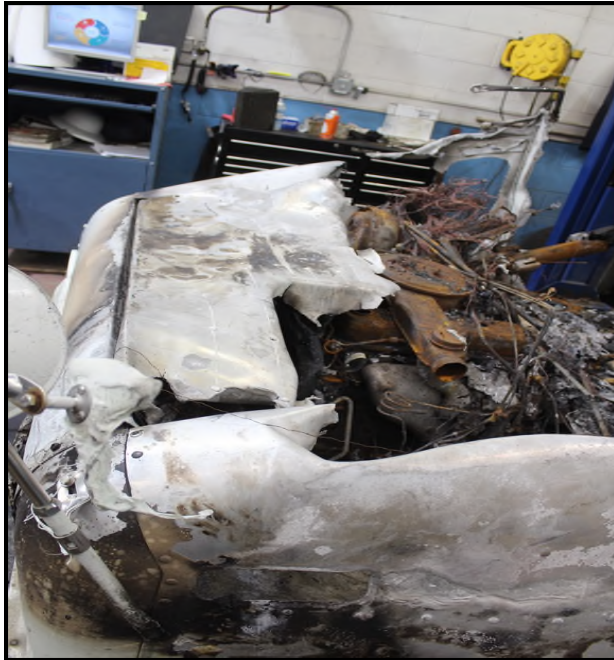
Photograph 5

Hood reconstructed, damage and collapse on mail side.

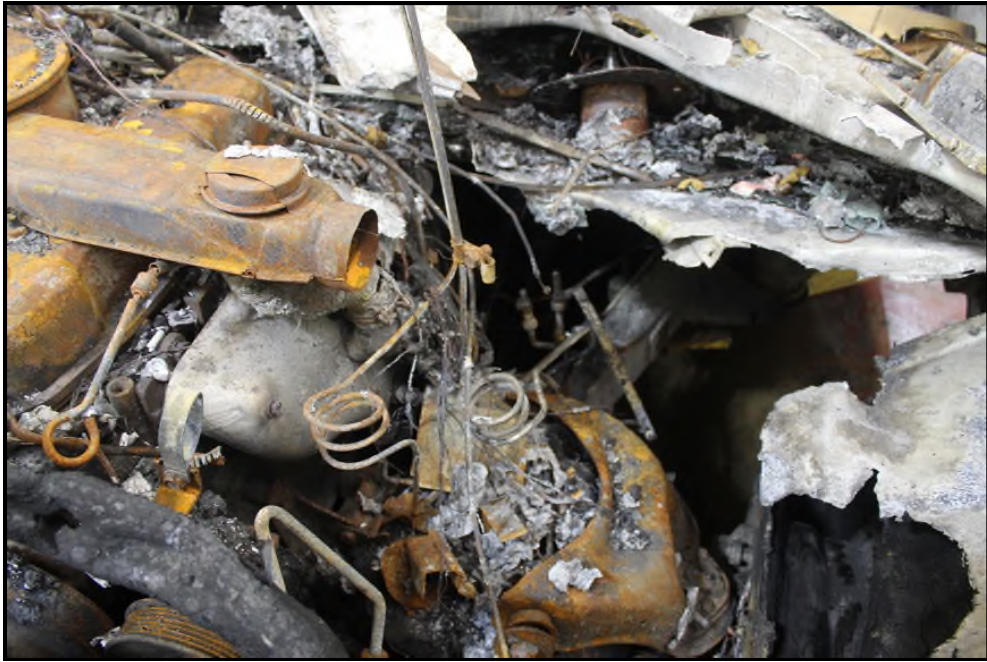
Photograph 11

Area of fire origin left mail side of engine compartment.

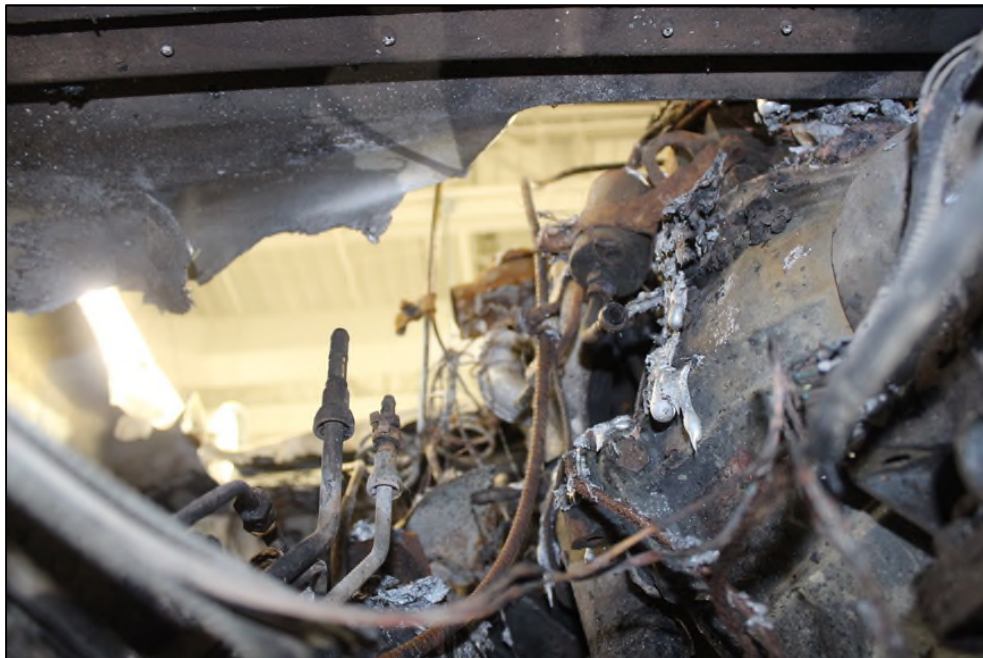
Photograph 12

Area of fire origin left mail side engine from below with fuel lines and filter.

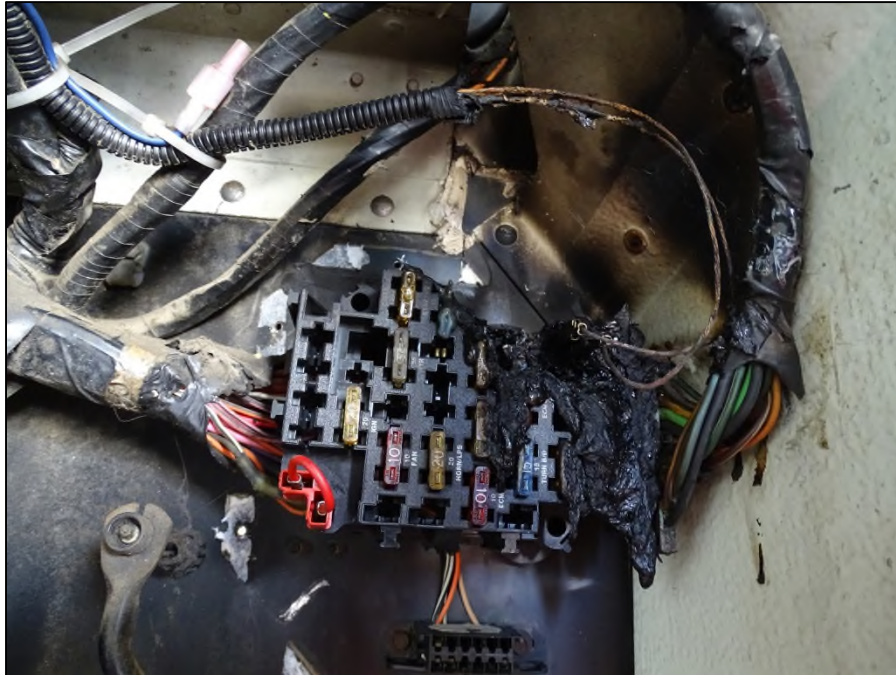
Photograph 9

Fuse panel, strobe box wire.

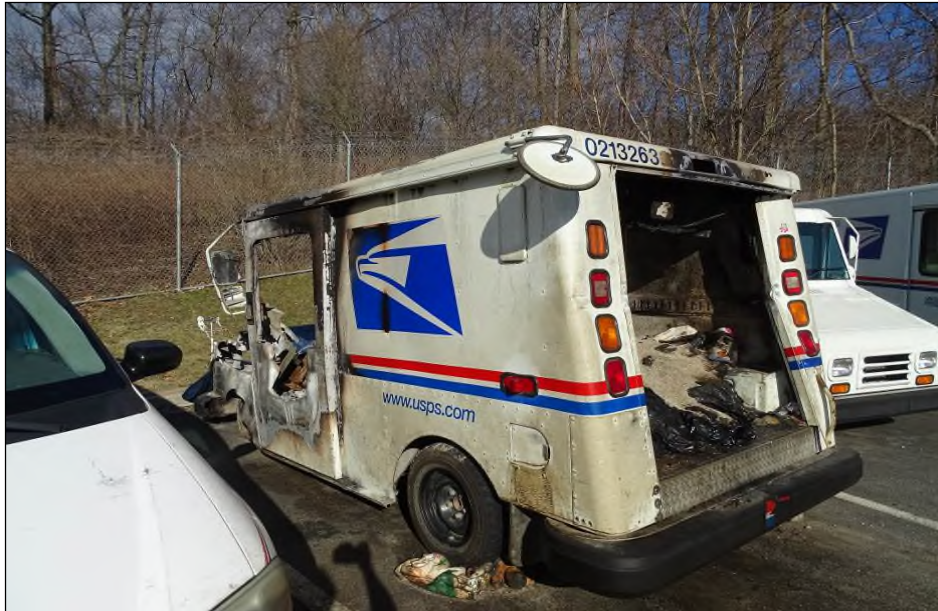
Photograph 1
View of fire damaged LLV.

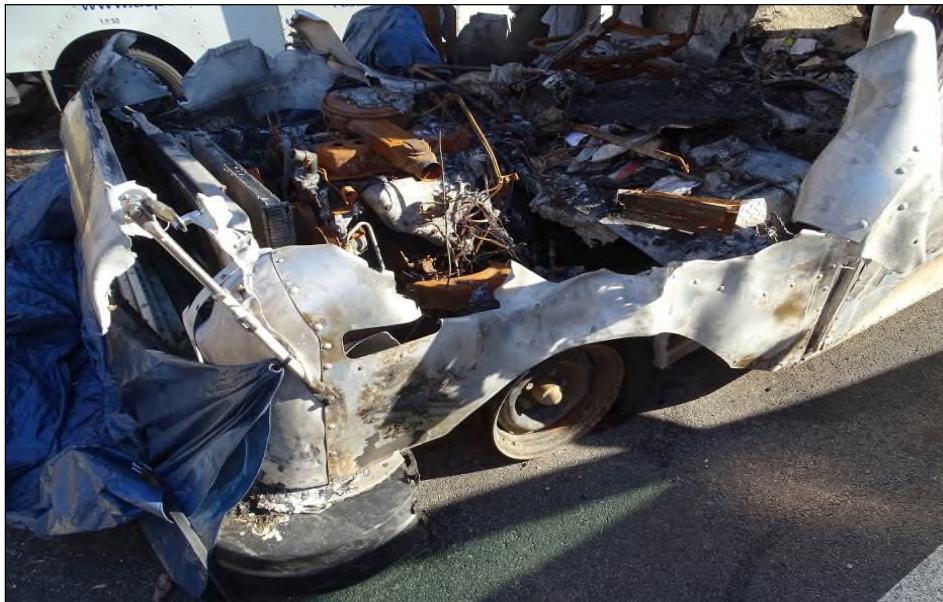
Photograph 2
View of damage to engine and passenger compartment.

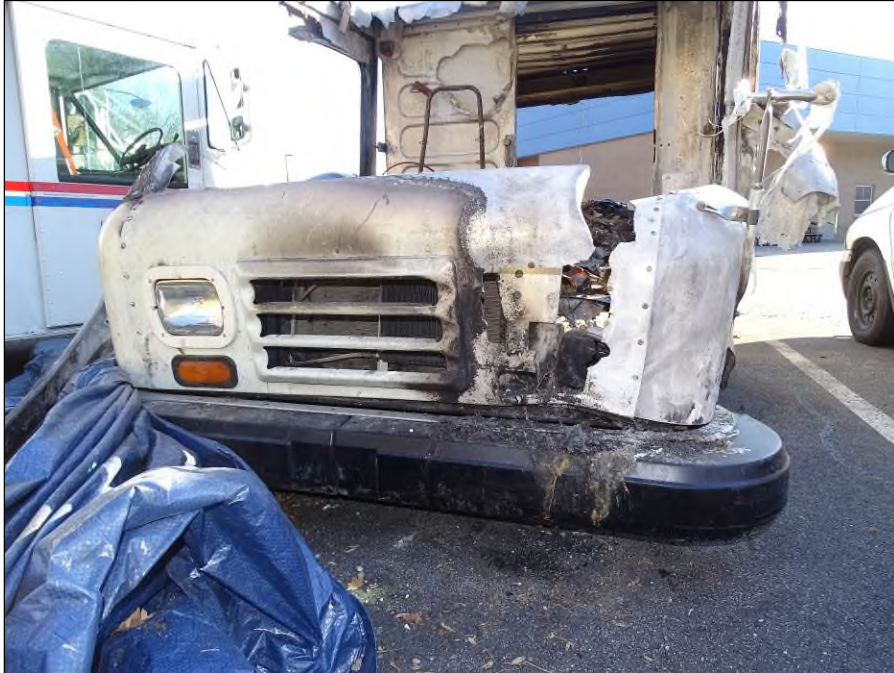
Photograph 3

View of area of origin surrounding the left side headlight assembly.

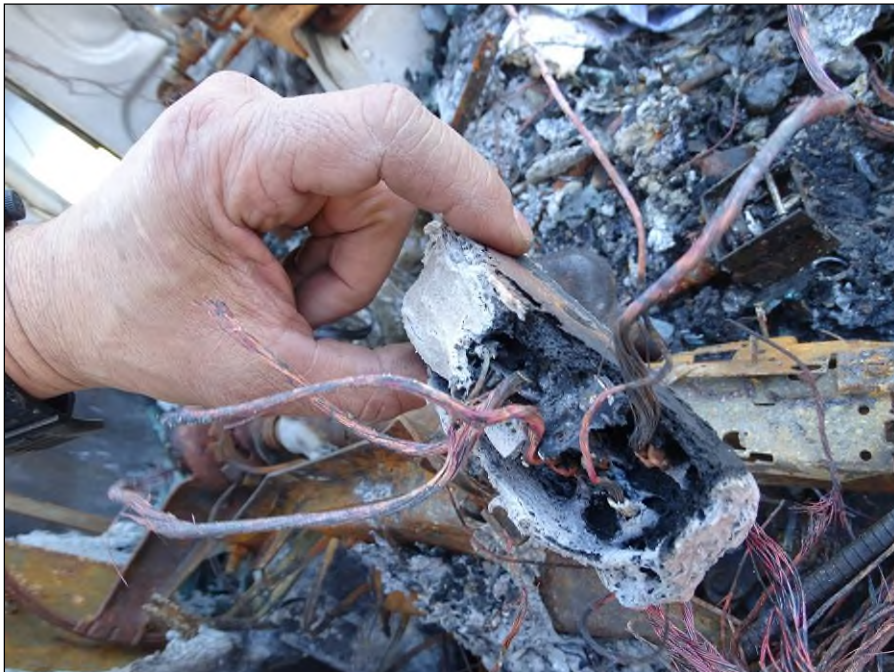
Photograph 4

View of fire damaged remains of Ignition Interrupter switch located on opposite side of engine compartment behind master brake cylinder.

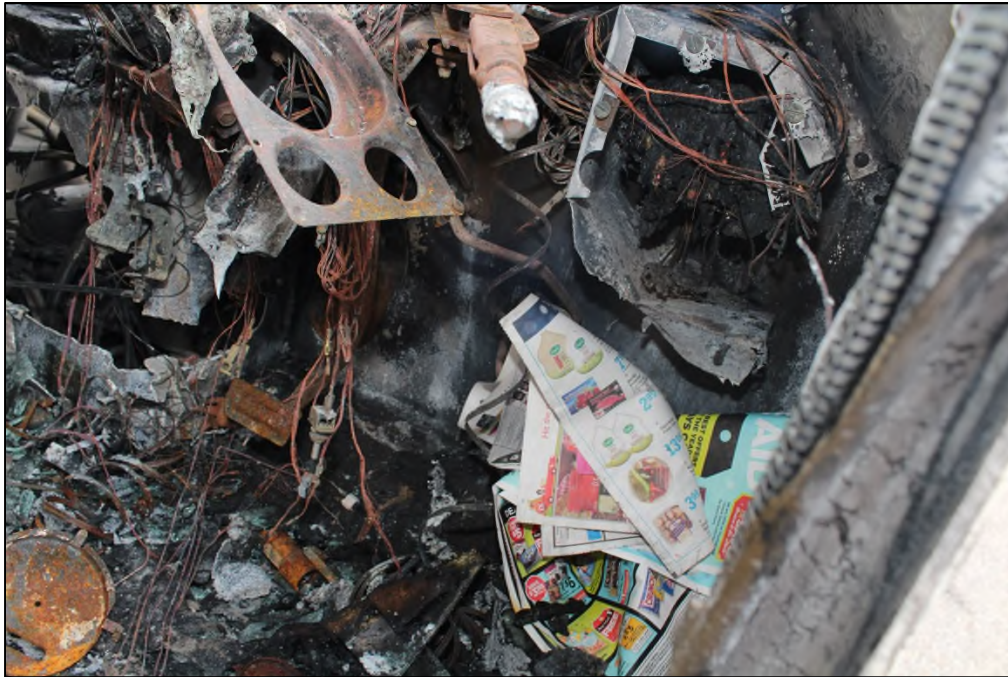
Photograph 5
Fuse Block.

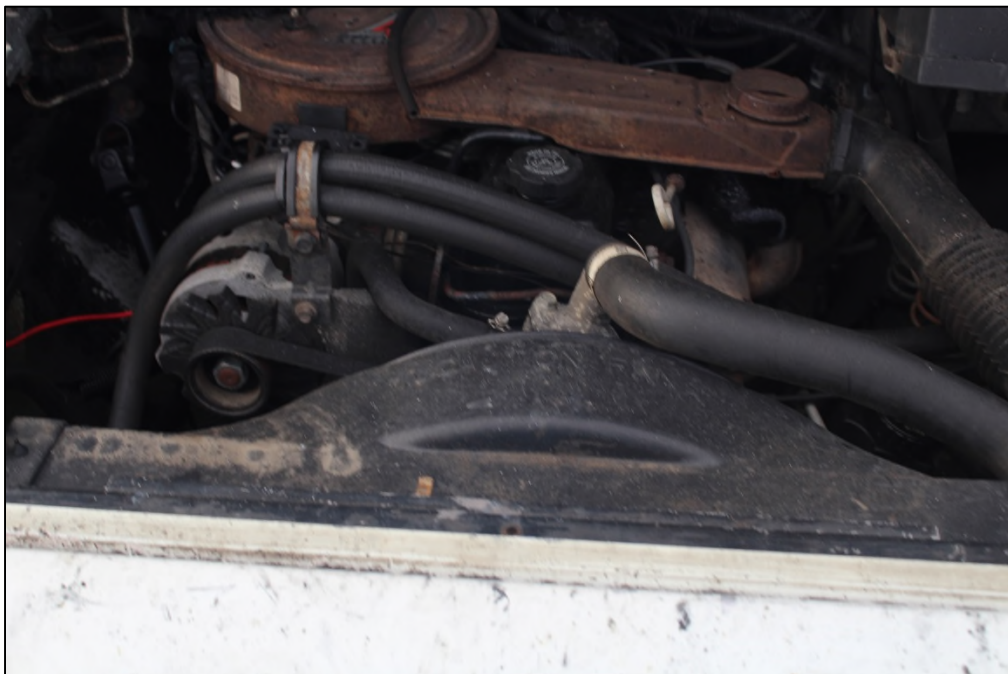
The engine compartment was examined. The vehicle was equipped with a GM 2.2L four-cylinder engine. The engine was equipped with a throttle body fuel injected system. The vehicle had a standard ignition coil. The engine compartment had sustained damage to the area rear of the engine. The front of the engine had no fire damage. The radiator and front grill had no damage. The hood release had sustained damage and was partially opened at the inspection time.

Photograph 6
Engine area.

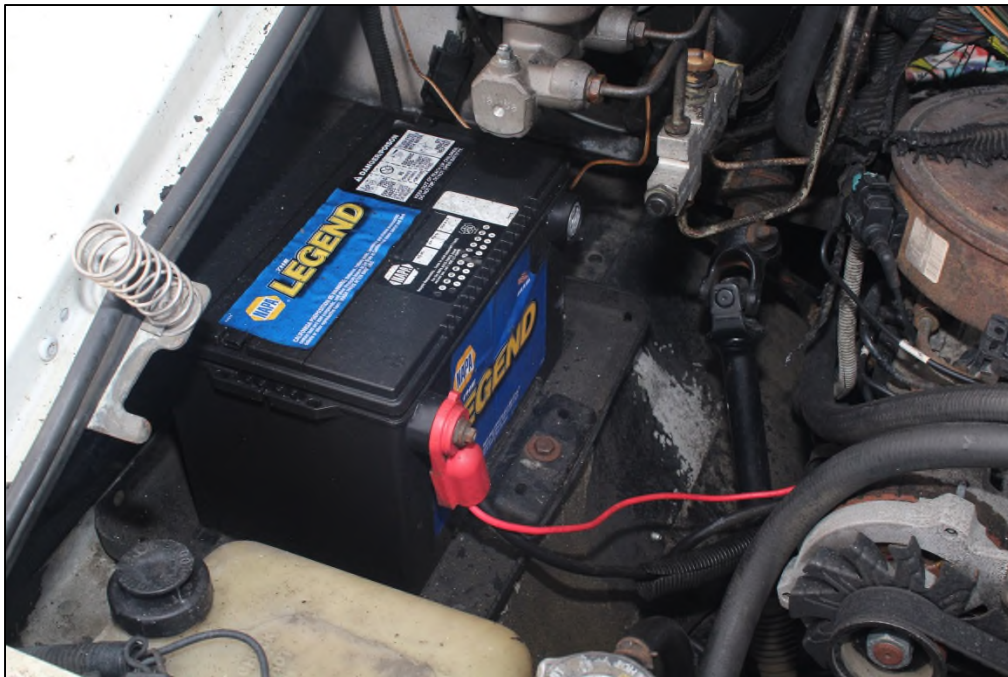
The battery for the vehicle was located at the front driver's side of the engine compartment. The battery, battery terminals, and battery cables were examined and found to be damaged by fire; no adverse electrical activity was observed. The battery, battery terminals, and battery cables were eliminated as a cause of the fire. The engine

Photograph 7
Battery.

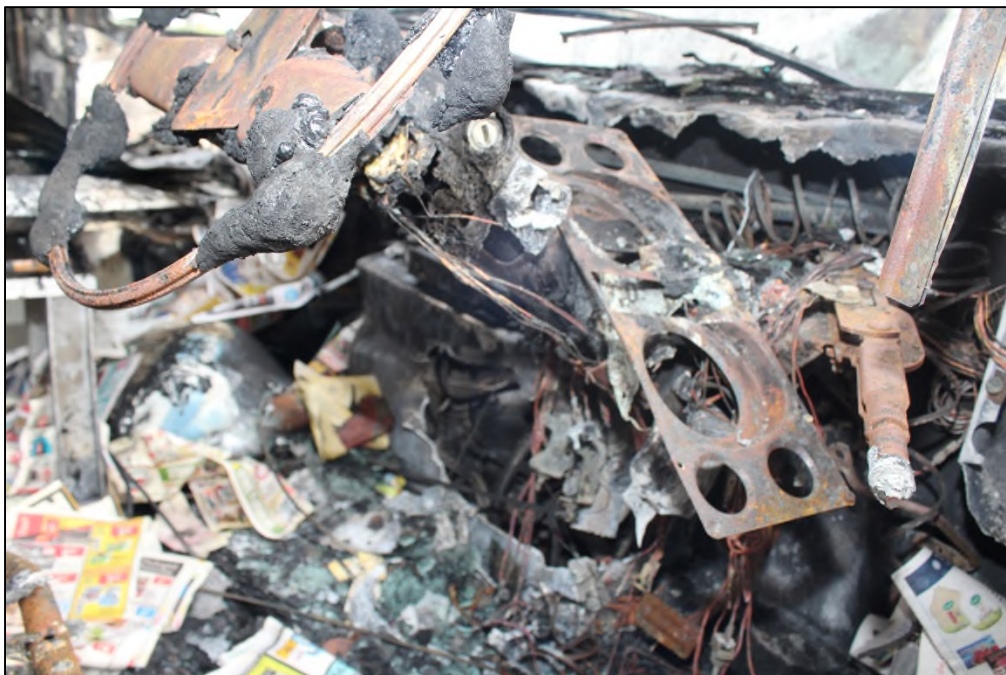
The interior of the driver's compartment had been damaged by the fire. All of the combustible materials in the dashboard had been consumed by the fire. The area located at the base of the bulkhead between the interior and the engine compartment had been consumed by the fire. The steering wheel and steering column had been consumed by the fire. The cargo area was damaged by the smoke and heat. This damage was less severe at the rear of this area and progressively increased towards the front of the area. An approximately 1x3 foot hole had been burned through the roof over the driver's side. The area around the engine bump out had an approximately 1x2 foot hole burned through the aluminum near the bottom edge. The fire had damaged some of the engine wiring at the rear of the engine.

Photograph 8
Dashboard.
